Manhole Inspection Summary

Manhole # S17EE2013MH

Insp Date: **7/13/06 2:36 PM**

Location Address: **5805 LOCHLEA RD**

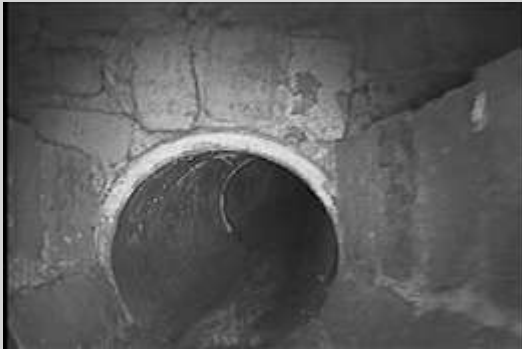
8 in. Circular Gravity Sewer Pipe Out @ 12 O'Clock

Rod and Bar (Angled)

Pipe Material: **Clay** ☐ Pipe Lined

Infiltration: **None** Pipe Seal Cond: **Unknown**
